Subject: Audible Spark Knock (Detonation), MIL Illuminated, DTC P0332 Set (Replace Rear Bank Knock Sensor and RTV Area Around Sensor) #02-06-04-023A - (06/14/2002)

Models: 1998-2002 Chevrolet Camaro, Corvette
1998-2002 Pontiac Firebird
with 5.7L Engine (VIN G -- RPO LS1)
1999-2002 Chevrolet Silverado, Suburban, Tahoe
2002 Chevrolet Avalance
1999-2002 GMC Sierra, Yukon, Yukon XL
2002 Cadillac Escalade, Escalade EXT
with 4.8L, 5.3L or 6.0L Engine (VINs V, T, Z, N, U -- RPOs LR4, LM7, L59, LQ9, LQ4)

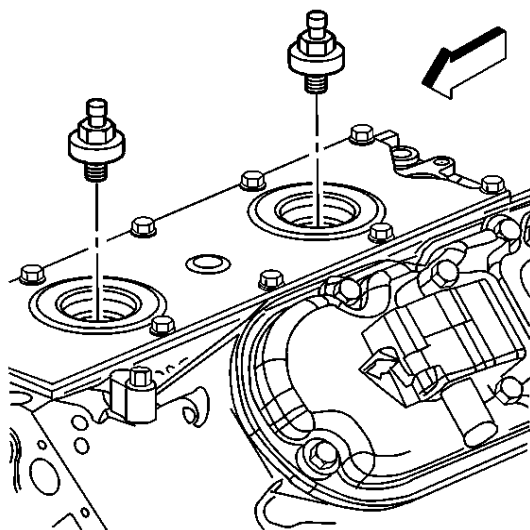
This condition may be the result of corrosion of the rear bank knock sensor due to water intrusion into the sensor cavity. This condition is more apparent on vehicles in which customers frequently wash the engine compartment.

3. Remove the rear bank knock sensor.
4. Install the new rear bank knock sensor.

Tighten the knock sensor to 20 N·m(15 lb ft).
