Document ID# 747273
2002 Chevrolet Corvette

Instrument Panel Upper Trim Pad Replacement

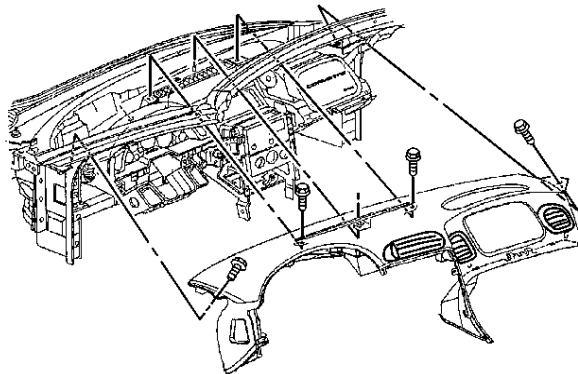
1. Remove the console. Refer to [Console Replacement](#) .
2. Remove the IP accessory trim plate. Refer to [Instrument Panel Accessory Trim Plate Replacement](#) .
3. Remove the driver knee bolster trim panel. Refer to [Driver Knee Bolster Panel Replacement](#) .
4. Remove the instrument panel compartment. Refer to [Instrument Panel Compartment Replacement](#) .
5. Remove the windshield defroster grille. Refer to [Defroster Grille Replacement](#) .
6. Insert the DRL and sunload sensors, if equipped, into the nearest openings in the windshield defroster duct.

Moving the sensors into the defroster duct provides additional clearance to remove the trim pad.

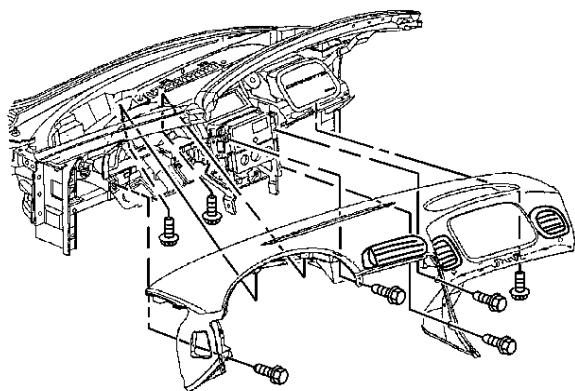
7. Remove the windshield side garnish moldings. Refer to [Windshield Side Garnish Molding Replacement](#) in Interior Trim.
8. Remove the screws retaining the upper trim pad to the defroster duct.
9. Remove the screws retaining the upper trim pad to the LH and RH hinge pillars.

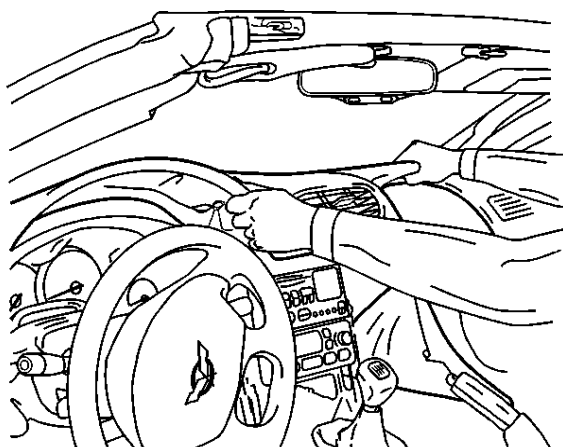
10. Remove the screws retaining the IP cluster bezel to the upper trim pad.
11. Remove the screws retaining the upper trim pad to the driver knee bolster outer bracket and the center support bracket.
12. Remove the screw retaining the upper trim pad to the passenger SIR bracket.

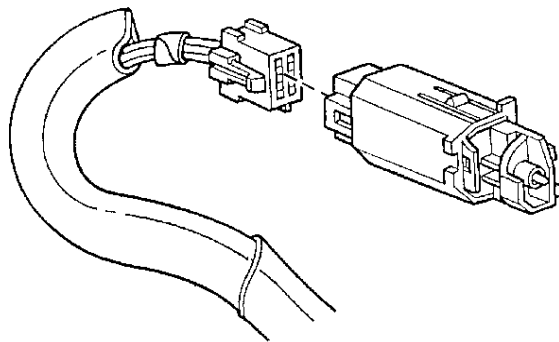
16. Disconnect the hazard warning switch electrical connector.
17. Remove the upper trim pad from the vehicle.

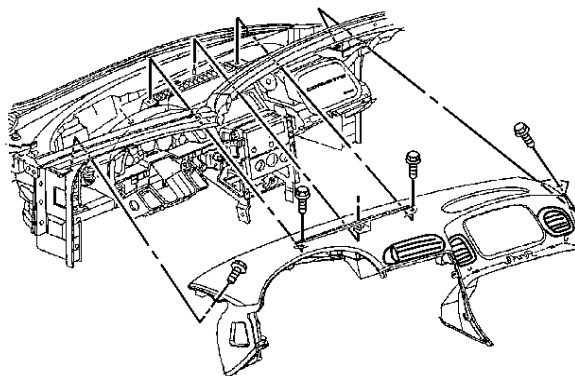
2. Install the IP upper trim pad into position.
 - 2.1. Tilt the forward edge of the trim pad down slightly.
 - 2.2. SLOWLY begin to move the trim pad into position while guiding the tabs on the LH and RH side of the trim pad past the hinge pillars.
 - 2.3. Locate the trim pad by guiding the alignment notch on the underside of the pad onto the alignment pin on the dash panel.
 - 2.4. Lower the rearward edge of the pad into place.
3. Remove the DRL and sunload sensors, if equipped, from the openings in the windshield defroster duct and position above the trim pad.

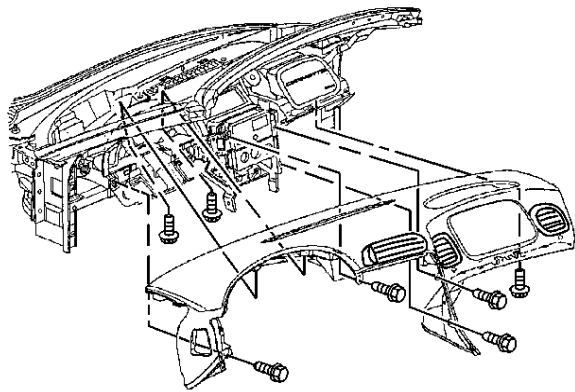
4. Install the screws retaining the upper trim pad to the windshield defroster duct.

Tighten the IP upper trim pad to windshield defroster duct screws to 1.9 N·m (17 lb in).

5. Install the screws retaining the upper trim pad to the LH and RH hinge pillars.

Tighten the IP upper trim pad to LH and RH hinge pillar screws to 2.5 N·m (22 lb in).
